## TUNING FORK CRYSTAL UNIT (Cylinder Type)

RoHS compliant / Pb free

## CFS-206 · CFS-145

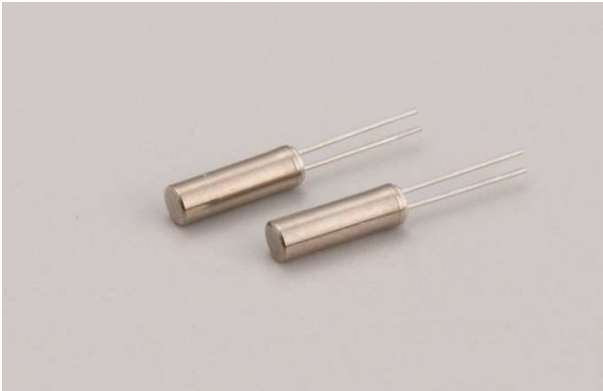
- Frequency range : 32.768kHz
- External dimensions (mm)  
CFS-206  $\Phi$  : 2.0 x L : 6.2  
CFS-145  $\Phi$  : 1.5 x L : 5.1
- Applications  
Watch / Clock / Security devices /  
Consumer products

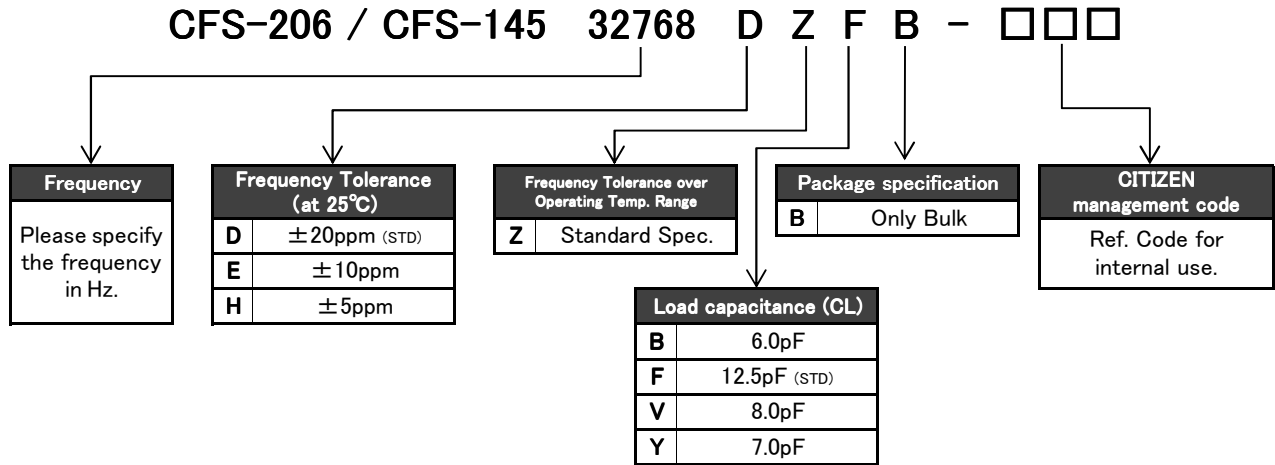
## ■ PART NUMBERING SYSTEM

\*Please contact us for specifications available.
